The Maine Installer

Volume 10 Issue 3

December 2003

Mending the Armor; Maine's Dispenser and Submersible-Pump Sump Study

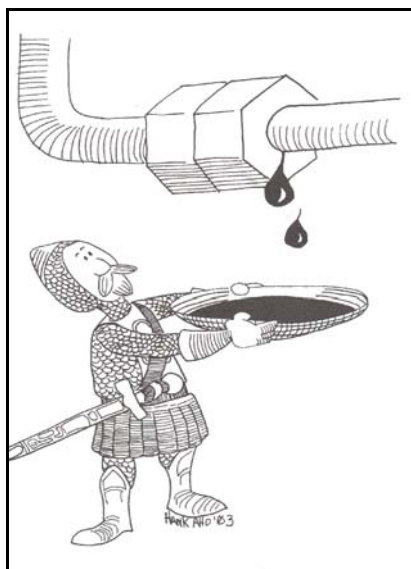
During Maine DEP's investigation, the tanks and piping were found tight, and no product was found in the dispenser or tank containment sumps. But after the removal of about 9,000 yards of contaminated soil, we estimated that some 6,000 gallons of super had been released into the ground. The interstitial space of the double-walled flexible piping between the dispensers was full of water and gas, and the hot-test soil reading was under the far super dispenser. We later found that the containment sump under this dispenser had a breach in the sump penetration where a Stage II vapor-recovery line entered the bottom of the sump.

It seemed that gas had leaked from somewhere in the dispenser into and out of the dispenser containment sump and that some of the gas had become

trapped in the double-walled piping between the dispensers. Product never made it to the tank-top piping sump, where it presumably would have been picked up by the leak-detection probe. As it was, the gasoline leaked out quicker than it could be detected. So it took bad coffee to announce that 6,000

Since the advent of flexible piping some 10 years ago, we have had a *de facto* dispenser containment sump requirement for all flexible piping, as the manufacturers require that all their fittings be housed in containment sumps. As illustrated in the opening story, using dispenser sumps without probes relies on product filling the dispenser sump up to a point where it can flow through the secondary piping back to the tank and then fill the tank sump to a level that trips the leak-detection probe – a kind of Rube Goldberg operation when you think of it!
